Trail Maintenance Pilot Project

**May to
September 2012**

Report

Crow Wing Trail Association

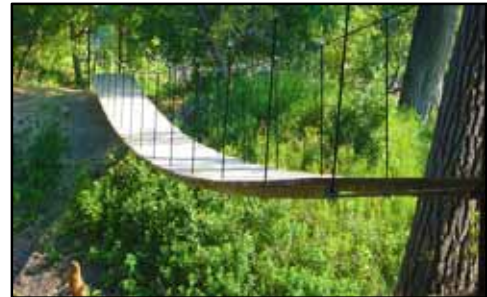
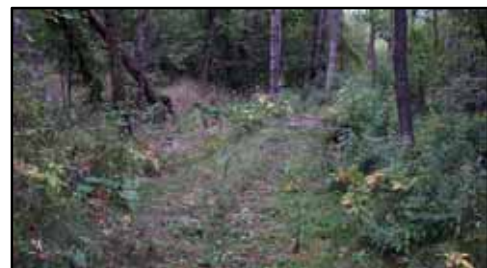
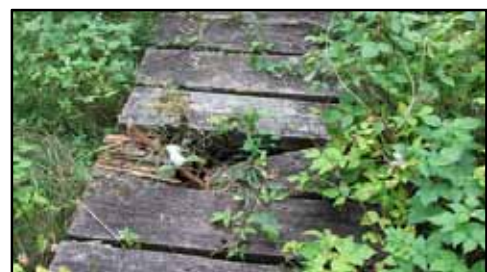
There was evidence that the south side of the bridge had been mowed, but the north side is further from the road, and so it takes more effort to get down there. A boardwalk over a low area has rotten boards that are weeded over, and the pathway is eroded. There has to be more vigilance with the maintenance of this section, as this bridge is the pride of the Rural Municipality of Franklin and a draw to the CWT.

Above: Senkiw Swinging Bridge; middle: south side path to bridge; bottom: rotten boardwalk boards.

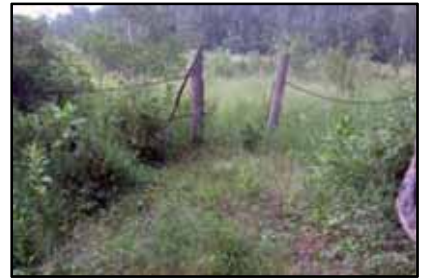
The trail past Mr. X's property is entirely on municipal roadway and is mostly bush. Someone has put up wooden posts at each end with chains and locks, apparently to discourage ATVs. This is a crucial piece of the trail, as it is the entrance into the RM of Franklin from the RM of De Salaberry, by way of the intermunicipal/meridian road. This sort of barrier is not welcoming to walkers or bikers. It says STAY OUT more than NO ATVS. This is entirely RM of Franklin road allowance, so it is really up to the municipality as to what is done. To mow would require moving the posts and then putting them back up again.

Private barrier erected to discourage ATVs.

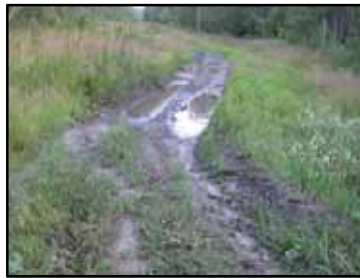
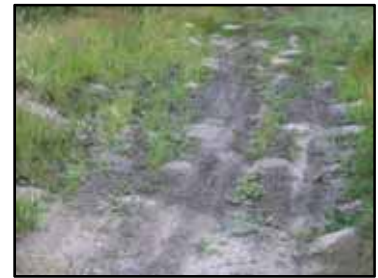
These two roads connect the RMs of De Salaberry and Franklin. Moose Creek Road has been damaged by ATVs; the Inter-municipal/meridian road is in slightly better condition.

Above: Moose Creek Road damaged by ATVs; below: intermunicipal/meridian road.

Moose Creek is almost impassable with a 4x4 truck, even when dry due to holes and rocks. What would be

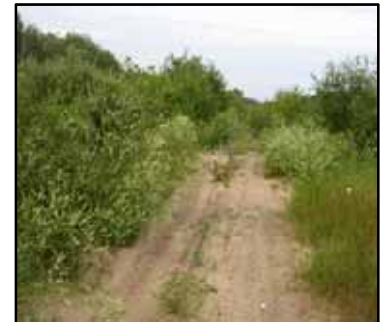
4.1.2.5 South of RM of De Salaberry disposal grounds

There are very deep ruts that will need levelling before any mowing can be done.

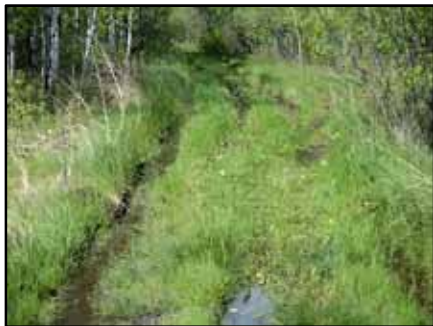
South of RM of De Salaberry disposal grounds.

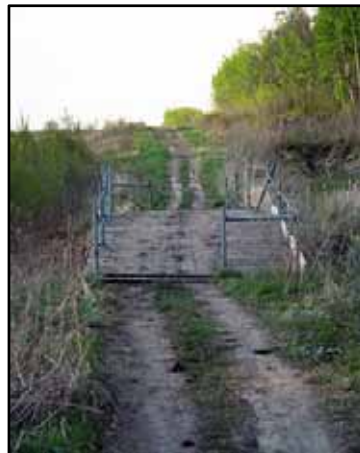
Bridge over Coulée des Naults.

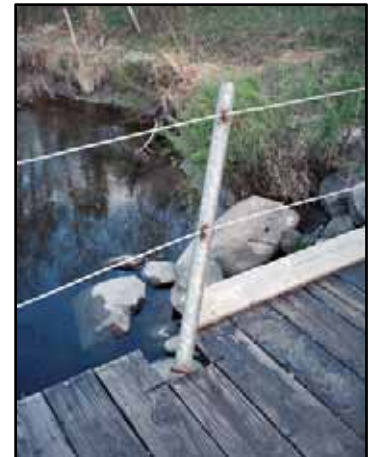
4.1.2.6 Twin Creek Road

The road has been washed out here following flooding. There is a long standing detour for vehicles. Pedestrians could cross the washout, but footing is not secure. The RM of Ritchot is waiting for the province to fix it.

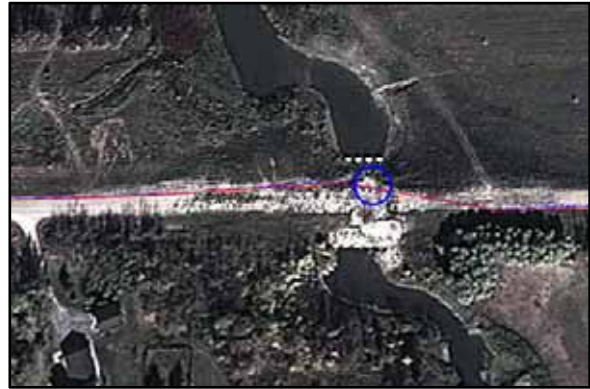
Twin Creek Road washout, one-mile north of St. Adolphe, just east of PR 200.

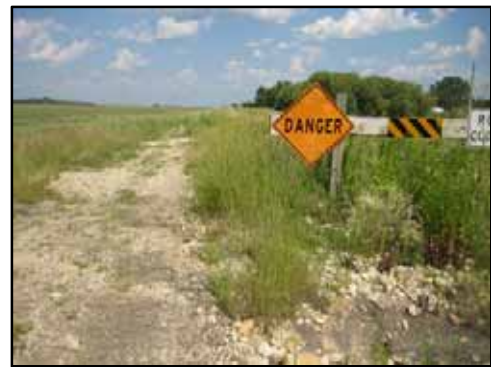
Twin Creek Road just west of wash out.

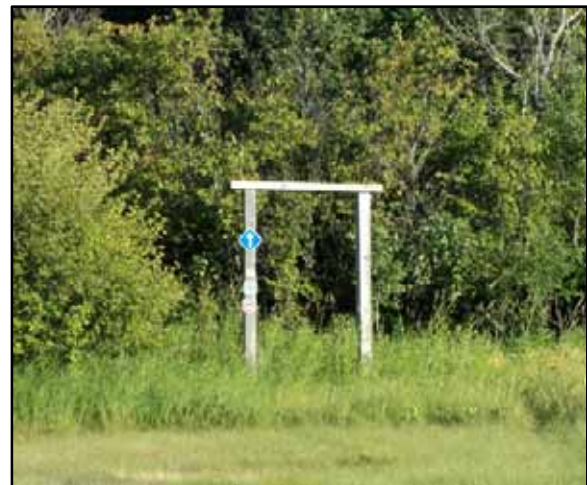
Greenridge CWT gate.

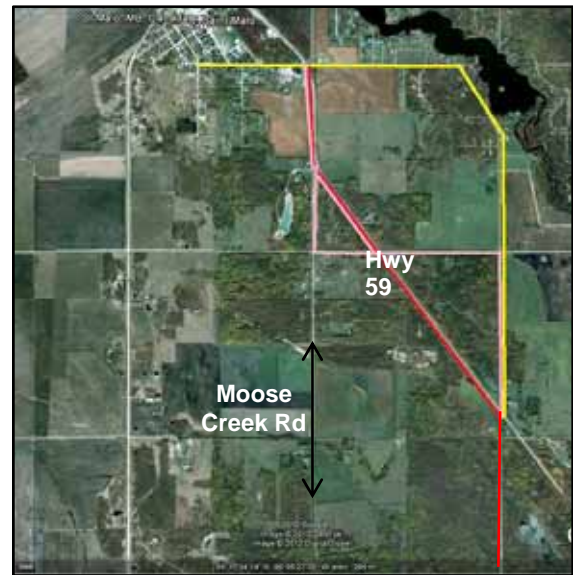
In discussing trail maintenance on the south end of the municipality (Moose Creek Rd) with the RM of De Salaberry, municipal council agreed to use the undeveloped road straight north of the blocked portion of the trail in Franklin instead of going west on the meridian road and then north on Moose Creek. As a result, the trail will come

Alternate routes to Moose Creek Rd at the south of the RM of De Salaberry.

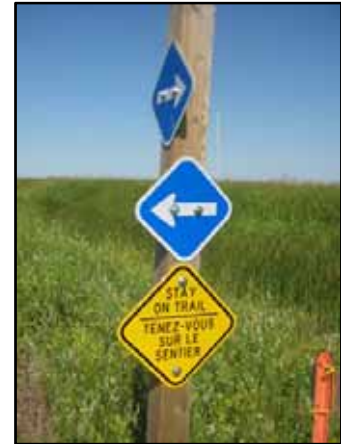
Two signs are needed on a corner where the trail turns.

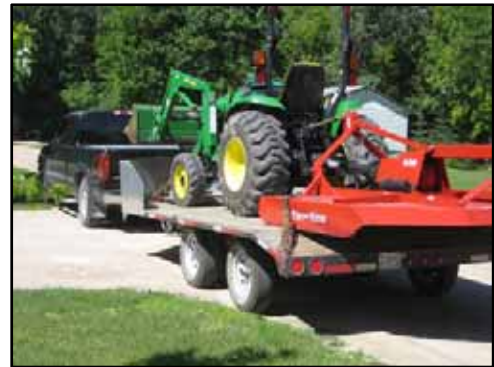
Each cutting day started with loading the tractor and mower and filling it with fuel. A 10-gallon can of fuel was taken along to prevent running short. All the equipment was checked, the mower blades sharpened, and the tie down chains re-cinched. Before returning the tractor and mower, they were always washed.

Tractor and bush mower rented from The Tractor People.

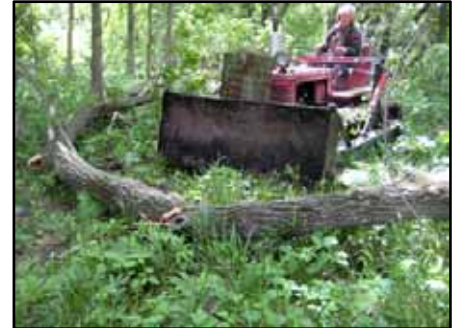
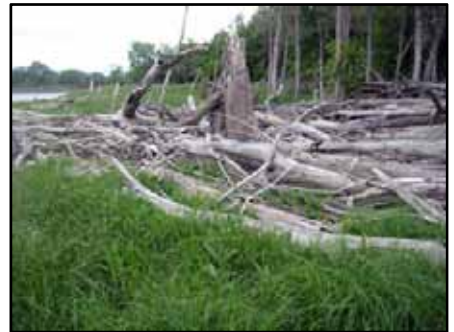
Trails on both sides of the river were cleared in preparation for mowing. The scenery along the river is diverse with tall green undergrowth, a well-treed canopy and a wide seven-foot swath. The treeless sections are tall grass.

Clearing the river trail at Emerson.

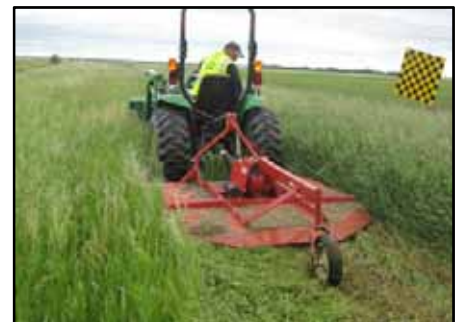
- grass on the boundary road was thick brome mostly, about three feet high
- no evidence of any traffic on this route – vehicles coming to the border from the north to check on crops, but no one else on it
- no signage until towards the eastern end of the border trail where the trail turns northward
- surface is quite rough with gopher holes and lots of dirt mounds
- averaging 40 minutes to cut a mile
- surprisingly there were no border patrol helicopters
- for a half mile were probably cutting in the US
- a farmer moved the ditch to get more land to seed, forcing the maintenance crew to hug the right side of the road along the American farmer's field

Mowing along the US-Canada border.

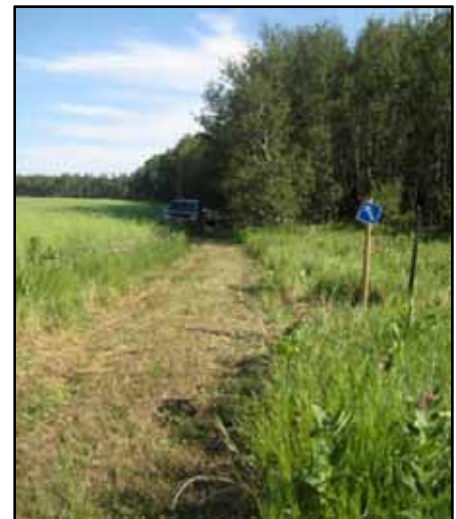
- on the last section of Hamilton's towards the narrow culvert, the field was seeded right to the bush line – cut a few feet of grain, mostly weeds

South side of Hamilton's trail

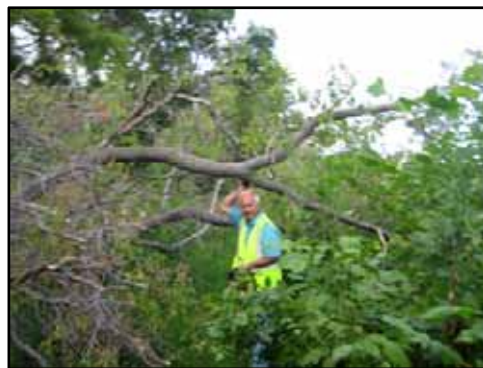
Cutting up downed maples north of St. Adolphe.

- chain-sawed at least four large maples that had fallen right across the trail and mowed through
- cut the south loop around the pond as well
- cut the west ditch along Hwy 200, which was marked with signs – no evidence of being used or mowed before as there was water in the ditch, now higher on the shoulder's grassy side to where the trail crosses Hwy 200 and heads eastward on Twin Creek Rd.

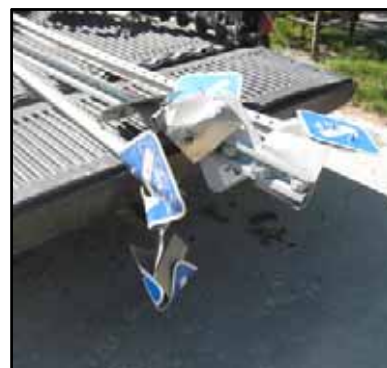
Load of damaged signs.

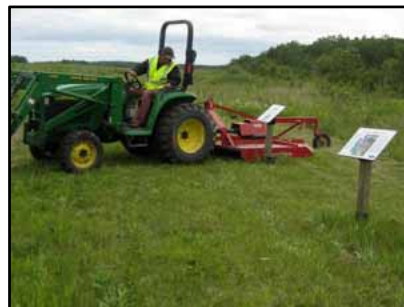
Interpretive signs east of La Rochelle.

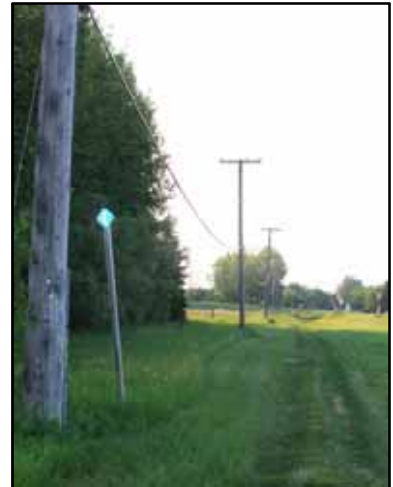
CWT directional sign atop a steel post in the RM of Ritchot.

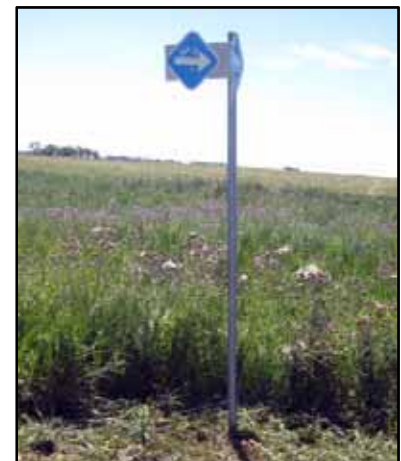
Type of steel post used in the rural municipalities of Franklin and De Salaberry

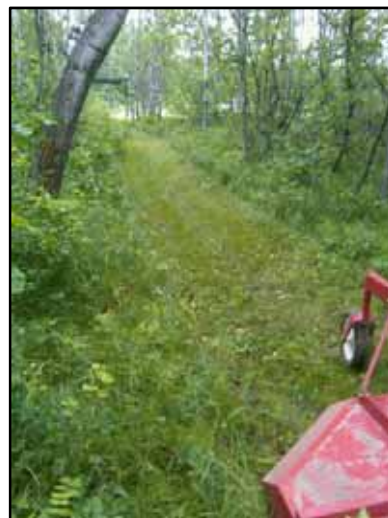
Mowing trail north of Senkiw Swinging Bridge.

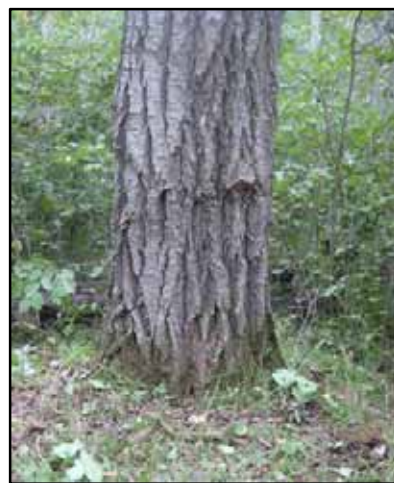
The poplar trees growing on either side of the trail are uncommonly large for this area. The width of this trunk, three feet up, measured 18 inches. A sign should be made pointing out its width, to make this tree an attraction and point out its rarity.

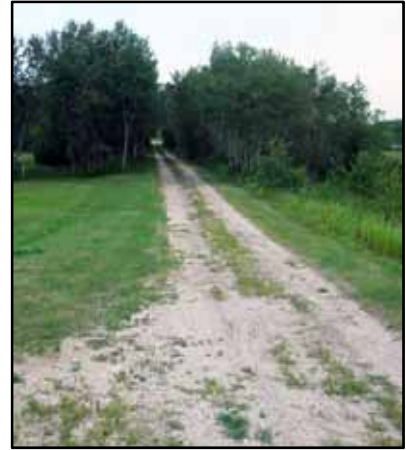
North end of alternate route for Moose Creek Rd.

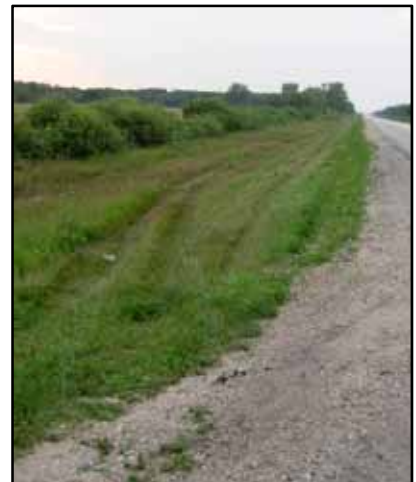
Evidence of ATV use in west ditch of Hwy 59 south of St. Malo.

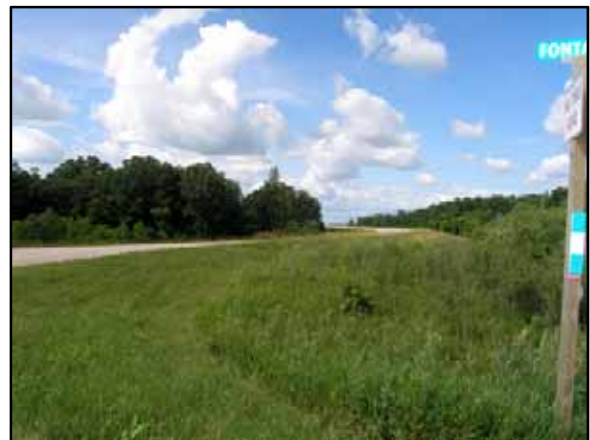
For a quarter mile, the CWT follows a curving PR 200, bordered by a steep ditch.

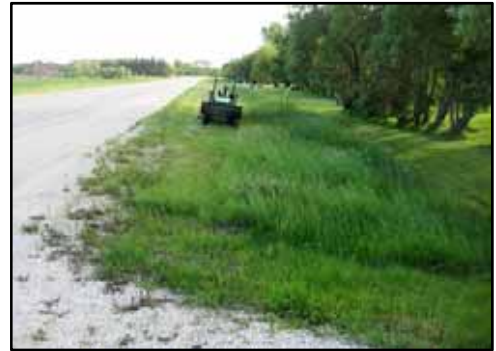
- weed whacked signs along Carrière Road into St. Adolphe from the south – trimmed trees covering directional sign just south of the dike
- followed the dike and mowed into the old park, but got lost and backtracked out – need to meet with St. Adolphe rep to see where to put up more signs in this old park as it was not clear where the trail goes
- mowed under the Red River bridge
- mowed along Hwy 200 north of St Adolphe – all the hydro poles were weed whacked to Twin Creek Road
- no more mowing after this point – did not proceed to the end of the trail to mow that quarter mile at the end where it hits the floodway – need direction from the Manitoba Floodway Authority on where to mow and sign

Mowing along St. Mary's Rd. (PR 200) north of St. Adolphe

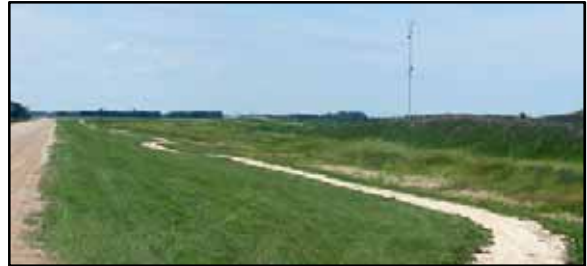
- important that the signs direct people to use the curving trail Niverville built on the north side of Crown Valley Road
- added blue signs on the railway crossing posts on Crown Valley Road and a new directional turn sign into Hespeler Park

Niverville trail north side of Crown Valley Road.
